Managing an Emergency Situation at Rochester Water Treatment Plant

Author - Greg Wood,
Regional Operations Manager NSW/VIC/TAS
Presented by – Matt Dawson
General Manager Business Development

Rochester Emergency January 2011

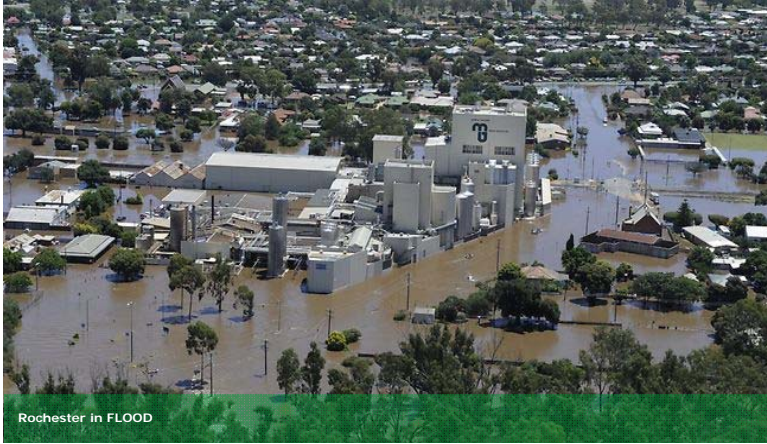
Rochester in FLOOD

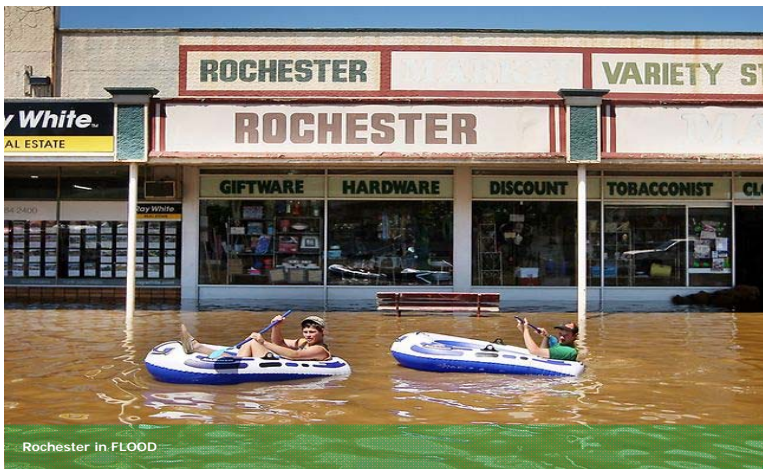
Rochester in FLOOD

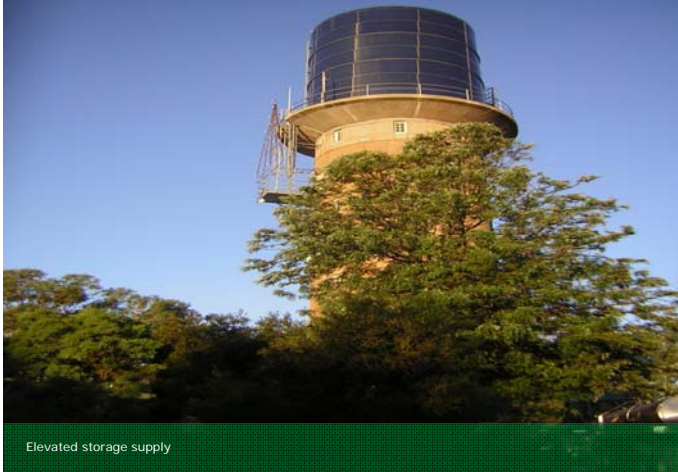
Elevated storage supply

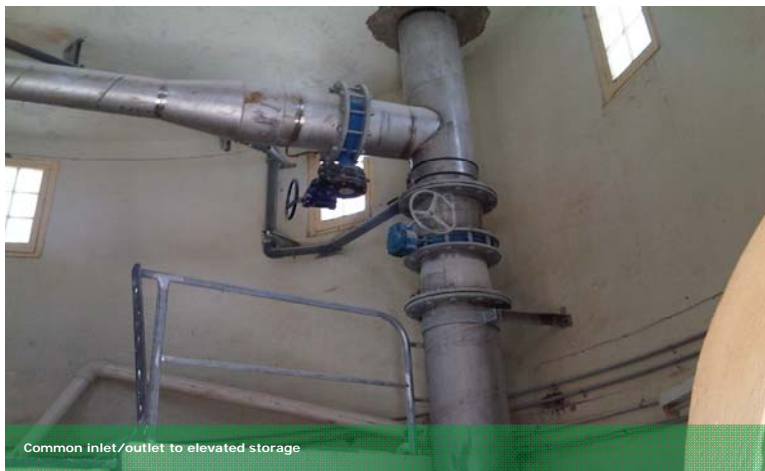
Common inlet/outlet to elevated storage

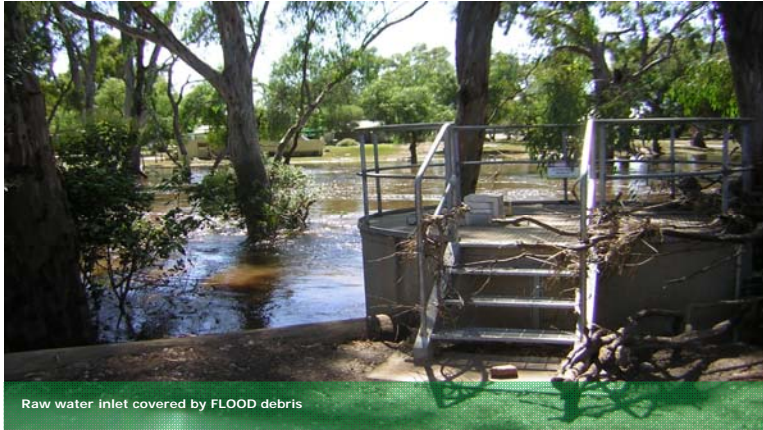
Raw water inlet covered by FLOOD debris

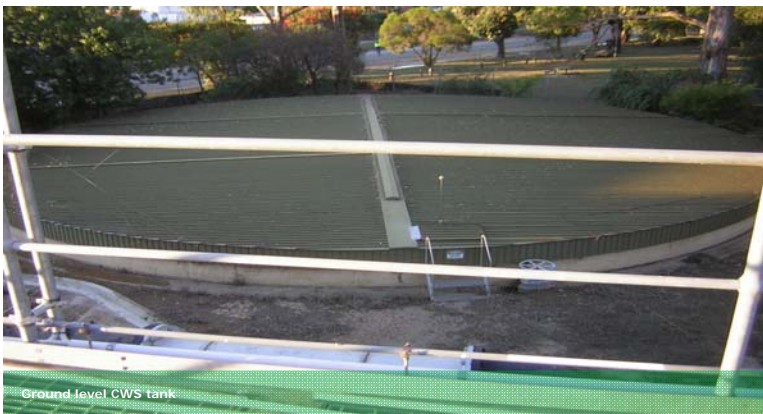
Ground level CWS tank

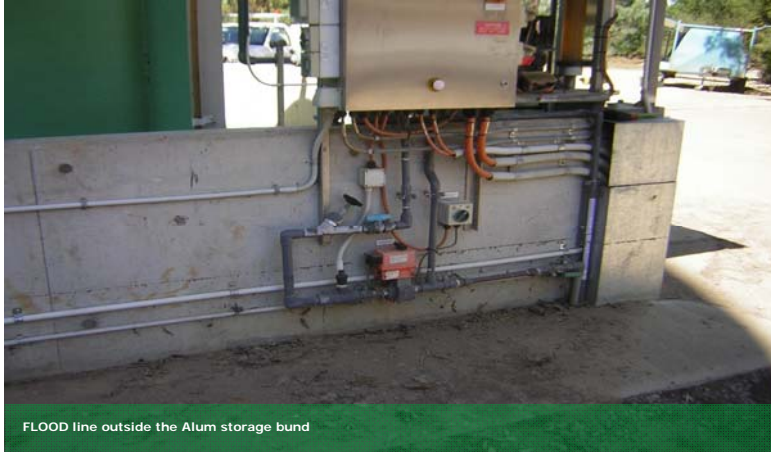
FLOOD line outside the Alum storage bund

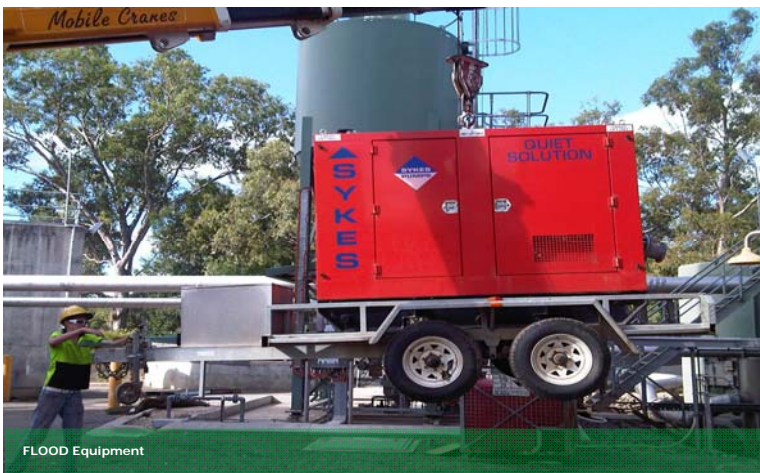
FLOOD Equipment

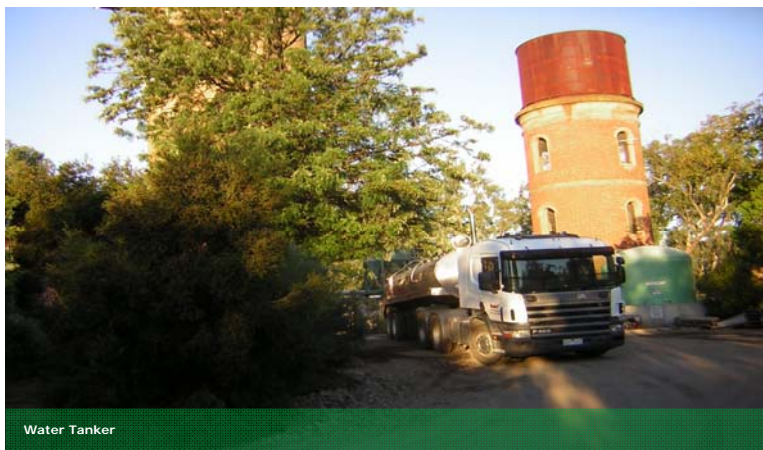
Water Tanker

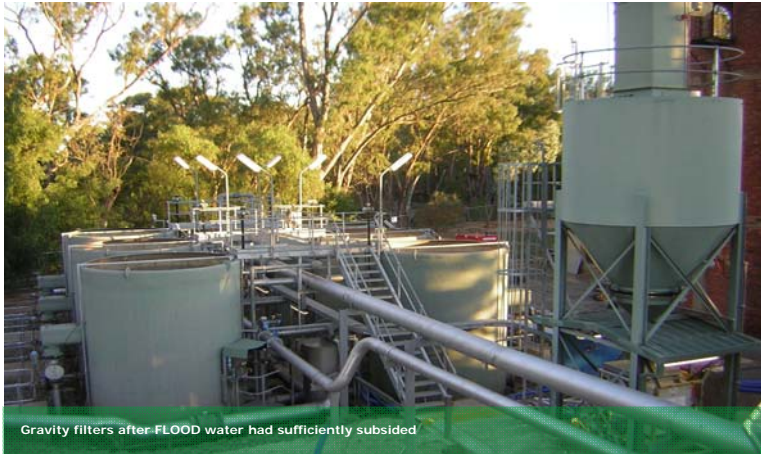
Gravity filters after FLOOD water had sufficiently subsided

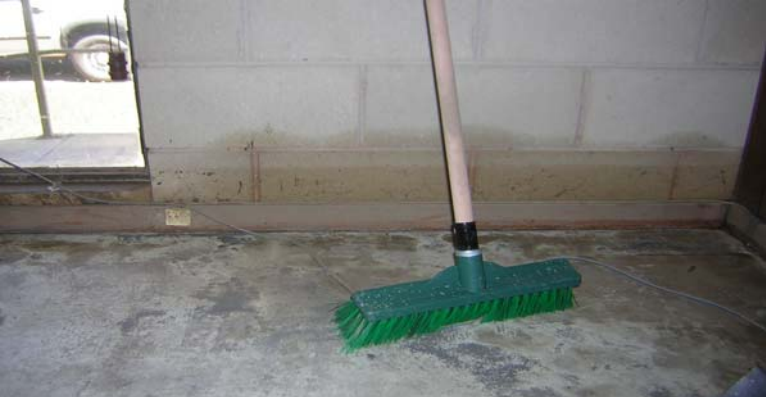
Control room FLOOD line visible (the carpet had been removed)

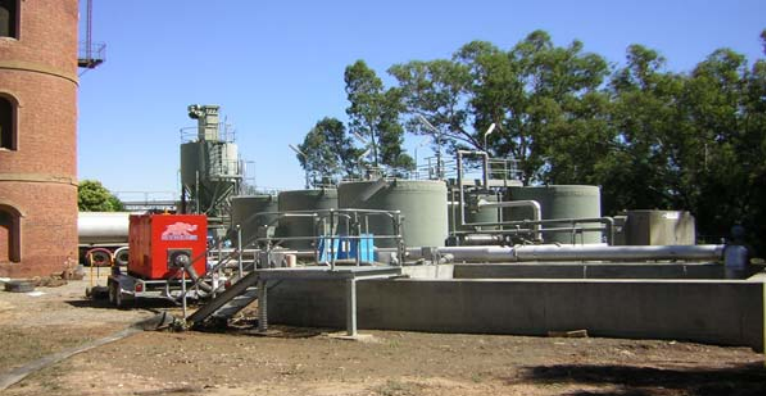
FLOOD equipment in use
