VIDEO MONITORING TO DETECT SALTWATER INGRESS IN SEWER MAINS

New methods to detect Saltwater Ingress in Wastewater Mains

T Hill, J Hearfield

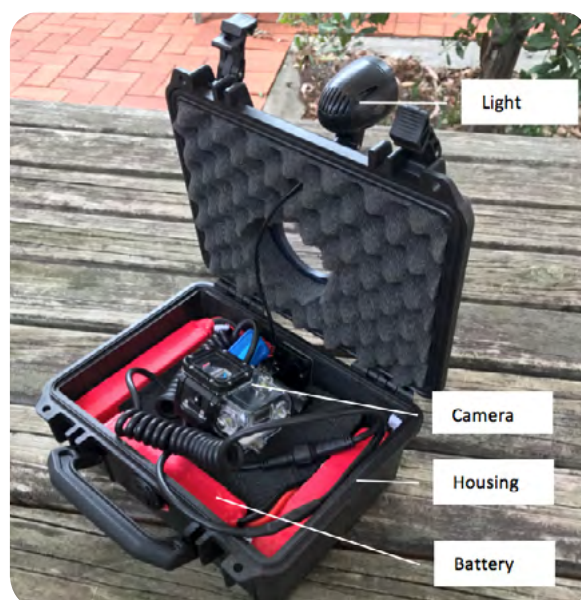
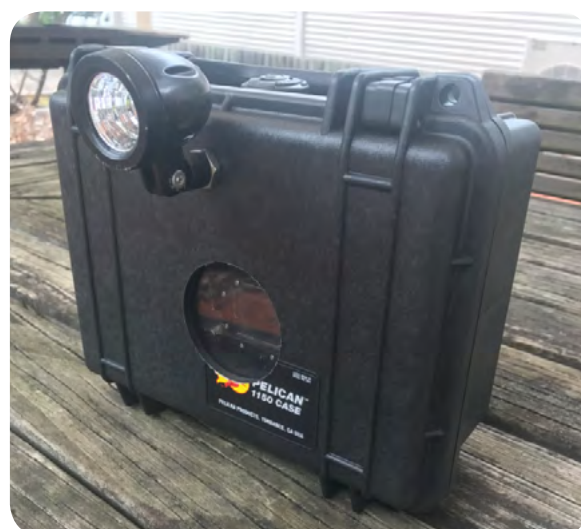
Figure 1. (Top) View inside of *SewCam* looking into the compartments containing GoPro®, 3x 12V batteries, light and housing. (Bottom) Front view of *SewCam*.

SewCam is comprised of four components, as depicted in (Figure 1), which include a camera, light, batteries and housing. The unit is user friendly and easily deployed with plug and play cables. Typical installation time is 45 minutes. The unit can record footage for up to 24 hours or can take up to 10,000 still images at pre-selected intervals (Table 1).

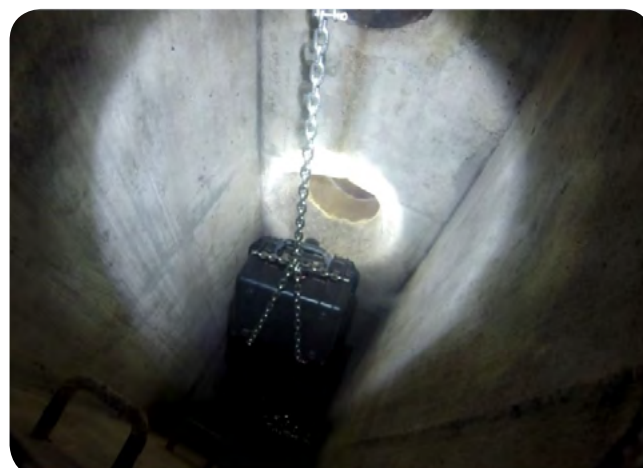
Figure 3. Photo of *SewCam* deployed to monitor an overflow within a maintenance hole.

SewCam is installed by suspension from chains attached to the top of the maintenance hole (Figure 2) and (Figure 3). Video monitoring captures up to 24 hours on continuous footage, so when carried out in conjunction with a forecast high tide, can provide video evidence of SWI. Historically four techniques have been used to monitor for SWI; site inspections, flow gauging, conductivity logging and CCTV. *SewCam* has reduced the number of site inspections and provided Sydney Water with video monitoring of assets during high tide that were previously unsafe to access for site inspections (Figure 4). *SewCam* has replaced the need for short term flow gauging and conductivity logging to detect SWI. *SewCam* also provides better source information for future CCTV investigations if required.

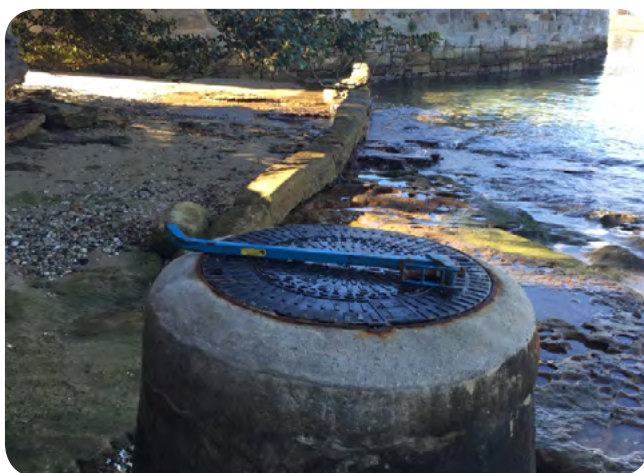
Figure 5. Accessible maintenance hole on harbour forshore. This can only be accessed during low tide as it is engulfed with tidal water at higher tides.

Site inspection involves manually opening maintenance holes to inspect for SWI source and direction. It can only be carried out on SPS, maintenance holes and designed overflows. Effective inspections need to be completed during high tide periods where maintenance holes are accessible and preferably during core business hours when SWI can be observed visually entering sewer mains. In many cases maintenance holes can only be safely accessed during low tide periods when not engulfed in tidal water (Figure 5).

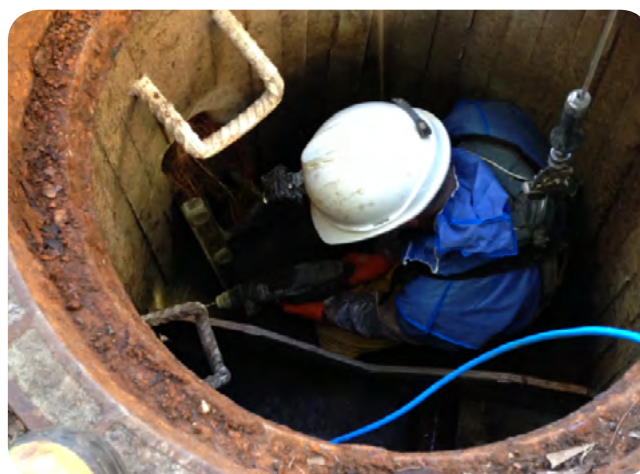
Figure 6. Technician occupying a confined space maintenance hole to install flow gauges and conductivity logging equipment.

This requires two technicians to conduct confined space entries in maintenance holes to install multiple flow gauges and conductivity sensors on sewer main inlets (Figure 6). A typical catchment investigation requires

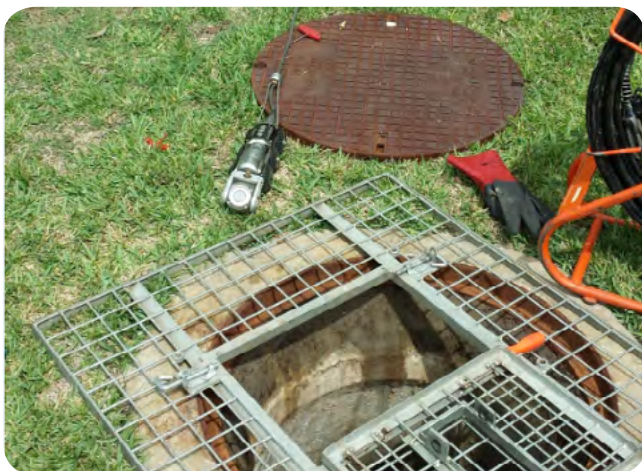
Figure 7. CCTV camera and tractor unit getting ready to be deployed into a maintenance hole. Unit is deployed into the sewer main and tractor unit is driven upstream or downstream looking for SWI sources entering the sewer main.

are moving through sewer mains. This can only be carried out from maintenance holes or inspection points that can be safely accessed (Figure 7). Timing this work during appropriate tidal heights is essential to effectively identify point sources of SWI. This generally results in long timelines when planning work on affected catchments to correlate appropriate tidal heights in dry weather conditions during daylight hours. A CCTV investigation costs roughly \$1,500 for one sewer main during one tidal event.

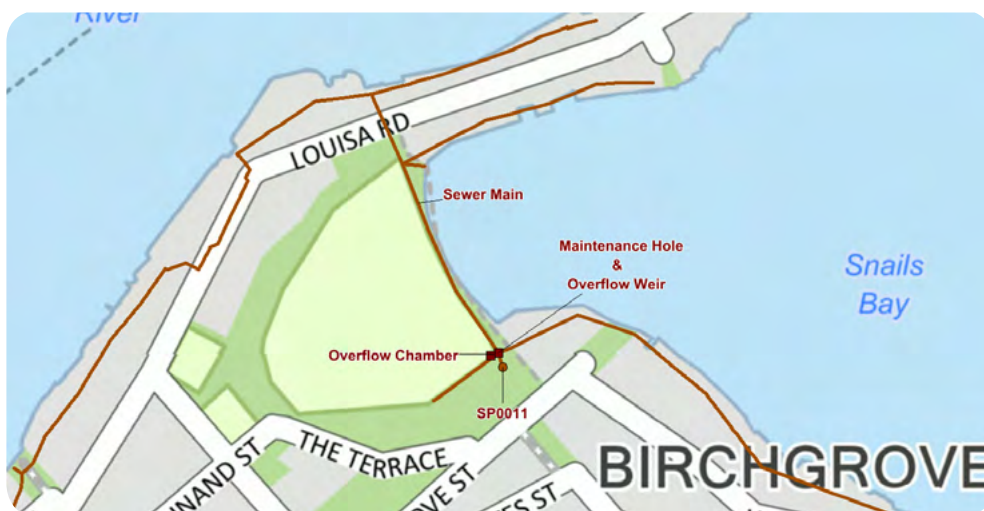
Figure 8. MapInfo layer marking the maintenance hole where SWI source detection monitoring was completed for SP0011. *SewCam* monitoring demonstrated that SWI was entering the sewer main from the overflow structure connected to the overflow chamber and underground stormwater during peak tides above 2.0m.

Source detection was carried out at the collecting maintenance hole to SP0011 (Figure 8). *SewCam* monitoring confirmed that SWI was entering from the overflow window (Figure 9) and the eastern sewer main is most affected by SWI. The detection of the overflow source alone is estimated at 8100KL per annum and represents 24% of SWI entering SP0011 catchment.

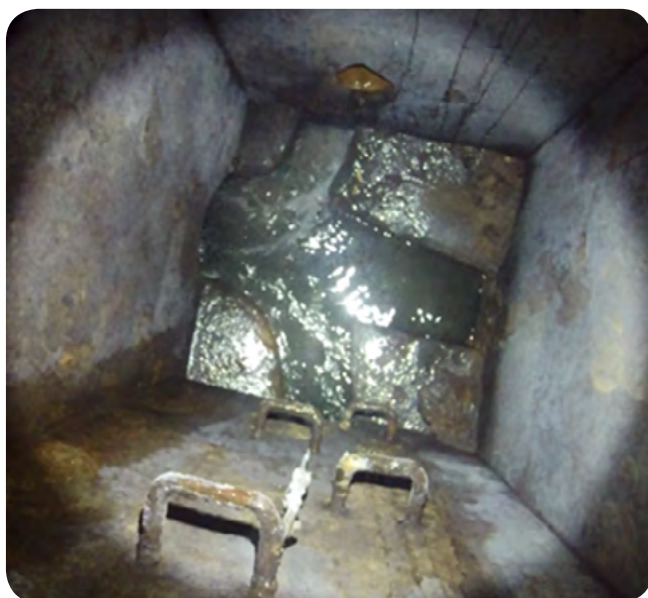
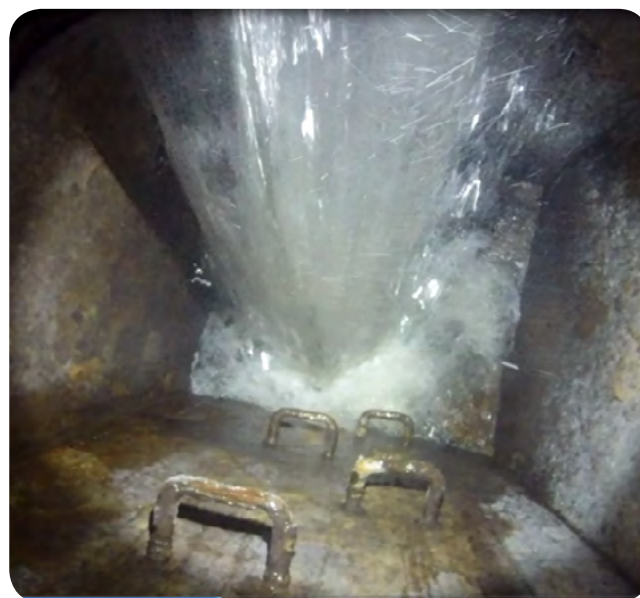
Figure 6. (Left) Still frame from SewCam footage of SP0011 collecting maintenance hole at low tide. (Right) Still frame from SewCam footage of the same maintenance hole at high tide showing SWI entering via the overflow window not visible in the frame.

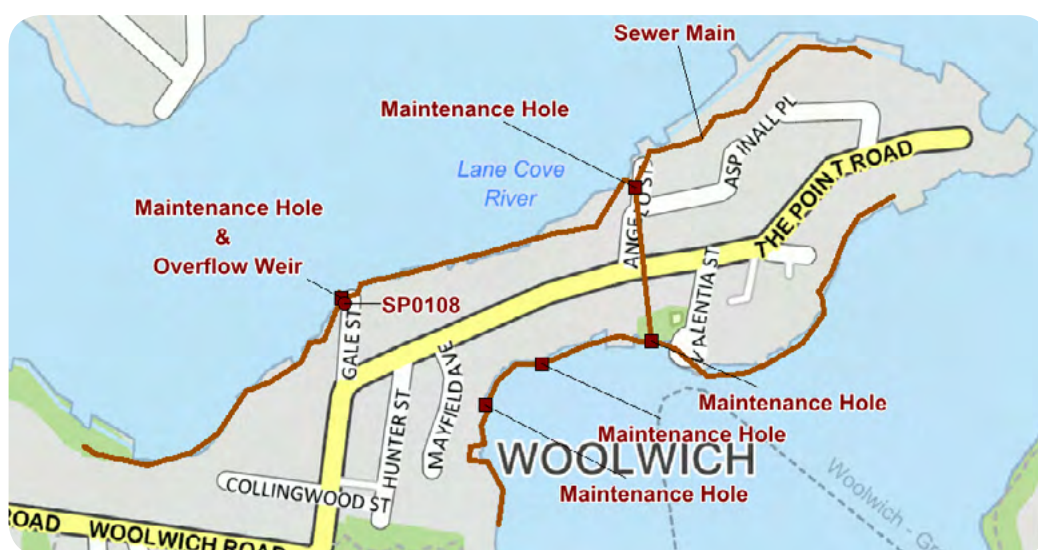
Figure 10. MapInfo layer marking the maintenance holes where SWI source detection monitoring was completed for SP0108. *SewCam* monitoring demonstrated that SWI is entering via the overflow weir, south-western and north-eastern sewer mains.

Source detection was undertaken at SP0108 from five maintenance holes using *SewCam* (Figure 10). Monitoring confirmed that the overflow weir to SP0108 was a source of SWI and that the north-eastern and south-western sewer mains are affected by SWI. The south-western sewer main is estimated to contribute around 14,000KL per annum representing 17% of total SWI. The north-eastern sewer main is estimated to contribute 9,000KL per annum and represent 11% of total SWI. Remaining SWI is therefore isolated to sewer mains directly east of SP0108 as remaining sewer mains have been eliminated based on *SewCam* analysis.

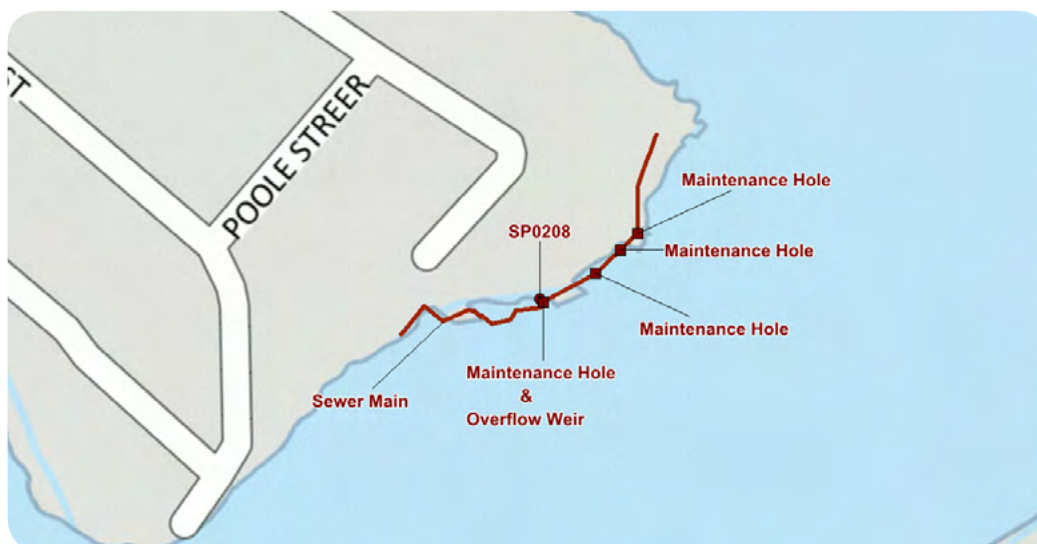
Figure 11. MapInfo layer marking the maintenance holes where SWI source detection monitoring was completed for SP0208. *SewCam* monitoring demonstrated that SWI is entering via damaged maintenance hole benching and isolated two sections of sewer mains north-east of SP0208.

Source detection was undertaken at SP0208 from four maintenance holes using *SewCam* (Figure 11). Monitoring confirmed that the north-eastern sewer mains from SP0208 are most affected by SWI.

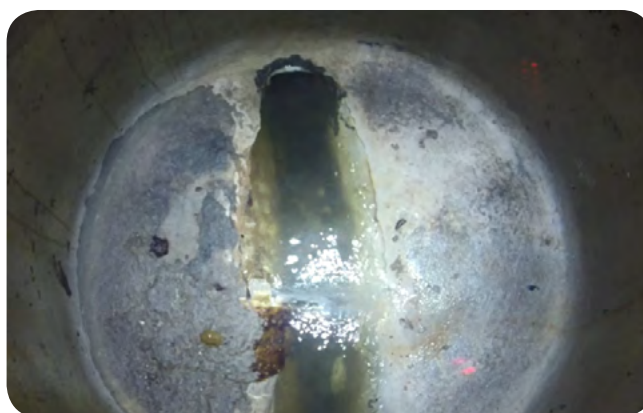
Figure 12. Still frame from *SewCam* footage from SP0208 maintenance hole with damaged benching. Black arrow indicates where SWI is entering from under the benching and into the channel.

Monitoring of three maintenance holes along the north-eastern line identified a major SWI source from damaged maintenance hole benching (Figure 12) and isolated two sections of affected sewer main for CCTV investigation. CCTV investigation and site inspections confirmed two major SWI sources from damaged HSL. The cumulative effect of the three SWI sources has reduced SWI by 8,300KL per annum and represents a 58% reduction in total SWI.
